LEE COUNTY COURTHOUSE

REPAIRS TO ADDRESS WATER INFILTRATION DURING HURRICANE HARVEY

SCOPE DEFINITION DOCUMENTS
PREPARED BY ACTON PARTNERS, LLC
JUNE 28, 2018

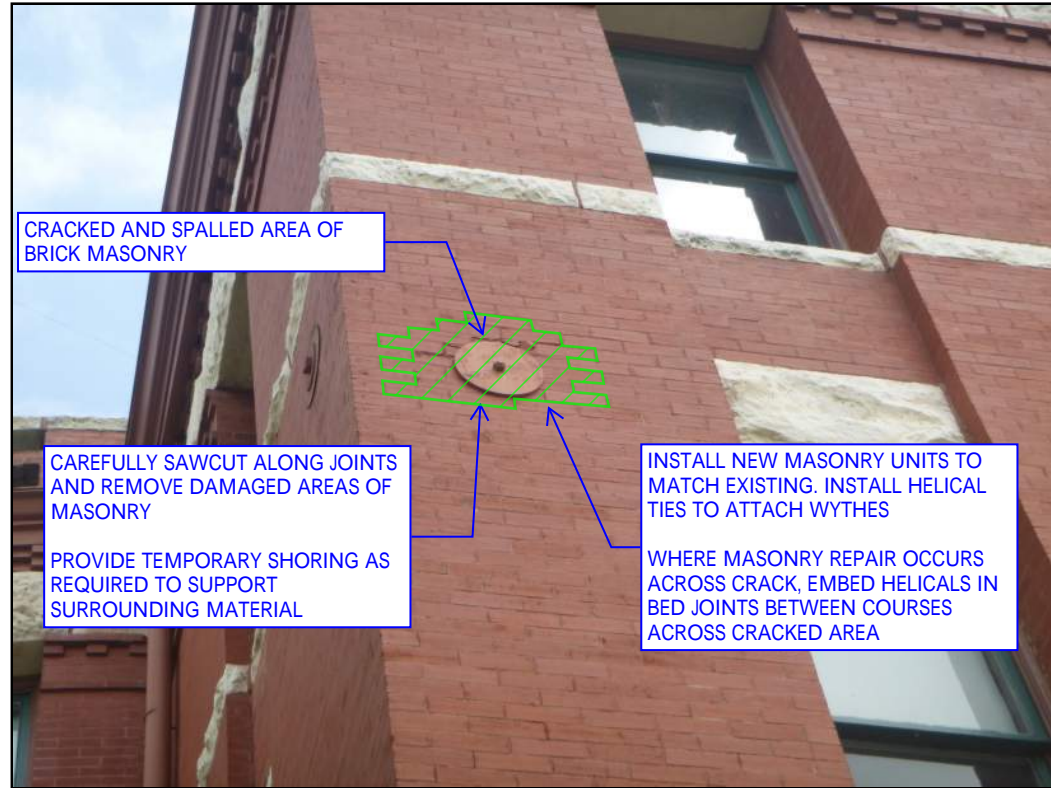
BRICK MASONRY REPAIR	2
scale: NTS

CRACKED AND SPALLED AREA OF BRICK MASONRY

CAREFULLY SAWCUT ALONG JOINTS AND REMOVE DAMAGED AREAS OF MASONRY

PROVIDE TEMPORARY SHORING AS REQUIRED TO SUPPORT SURROUNDING MATERIAL

INSTALL NEW MASONRY UNITS TO MATCH EXISTING. INSTALL HELICAL TIES TO ATTACH WYTHES

WHERE MASONRY REPAIR OCCURS ACROSS CRACK, EMBED HELICALS IN BED JOINTS BETWEEN COURSES ACROSS CRACKED AREA
