LEE COUNTY COURTHOUSE GIDDINGS, TEXAS

HURRICANE HARVEY REPAIRS DISTRESS AND WATER INFILTRATION

BID SET - SCOPE DEFINITION DOCUMENTS PREPARED BY ACTON PARTNERS, LLC MARCH 9, 2019

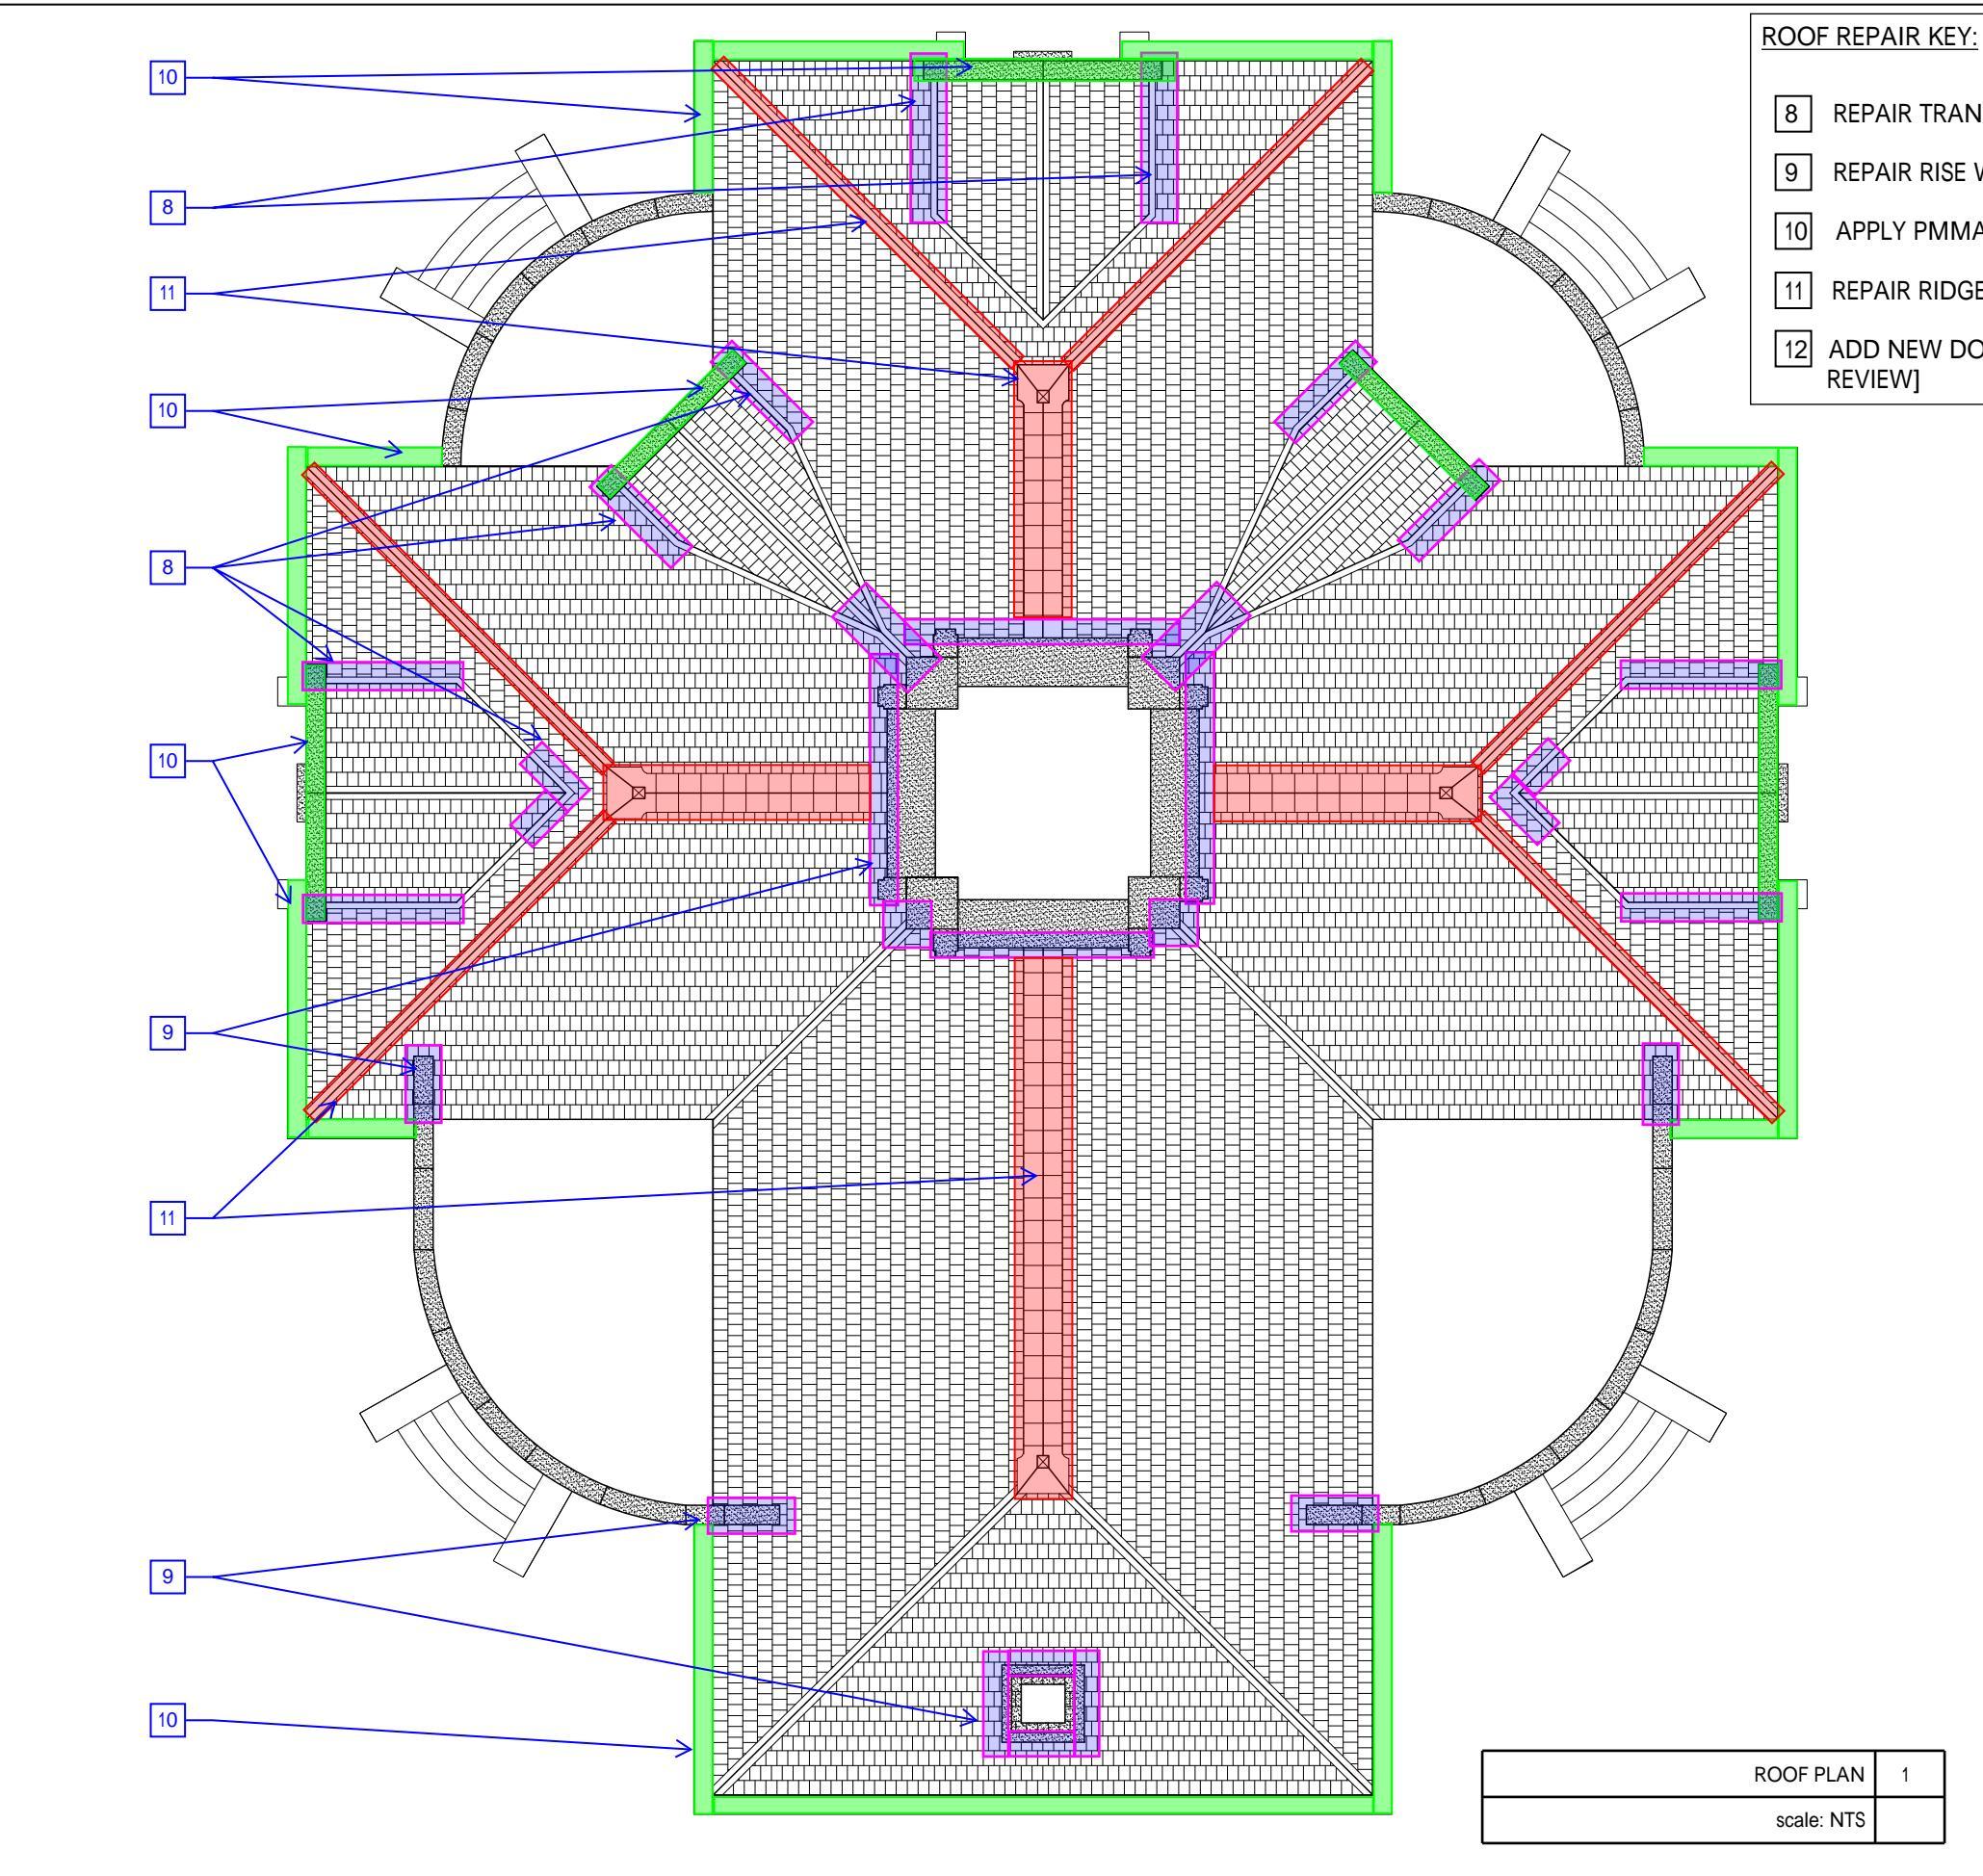
- 8 REPAIR TRANSITION FLASHING PER 8/R3.2
 - REPAIR RISE WALL FLASHING PER 9/R3.2
- 10 APPLY PMMA COATING PER 10/R3.3
- 11 REPAIR RIDGE CAPS PER 11/R3.3

12 ADD NEW DOWNSPOUT [SUBJECT TO THC REVIEW]

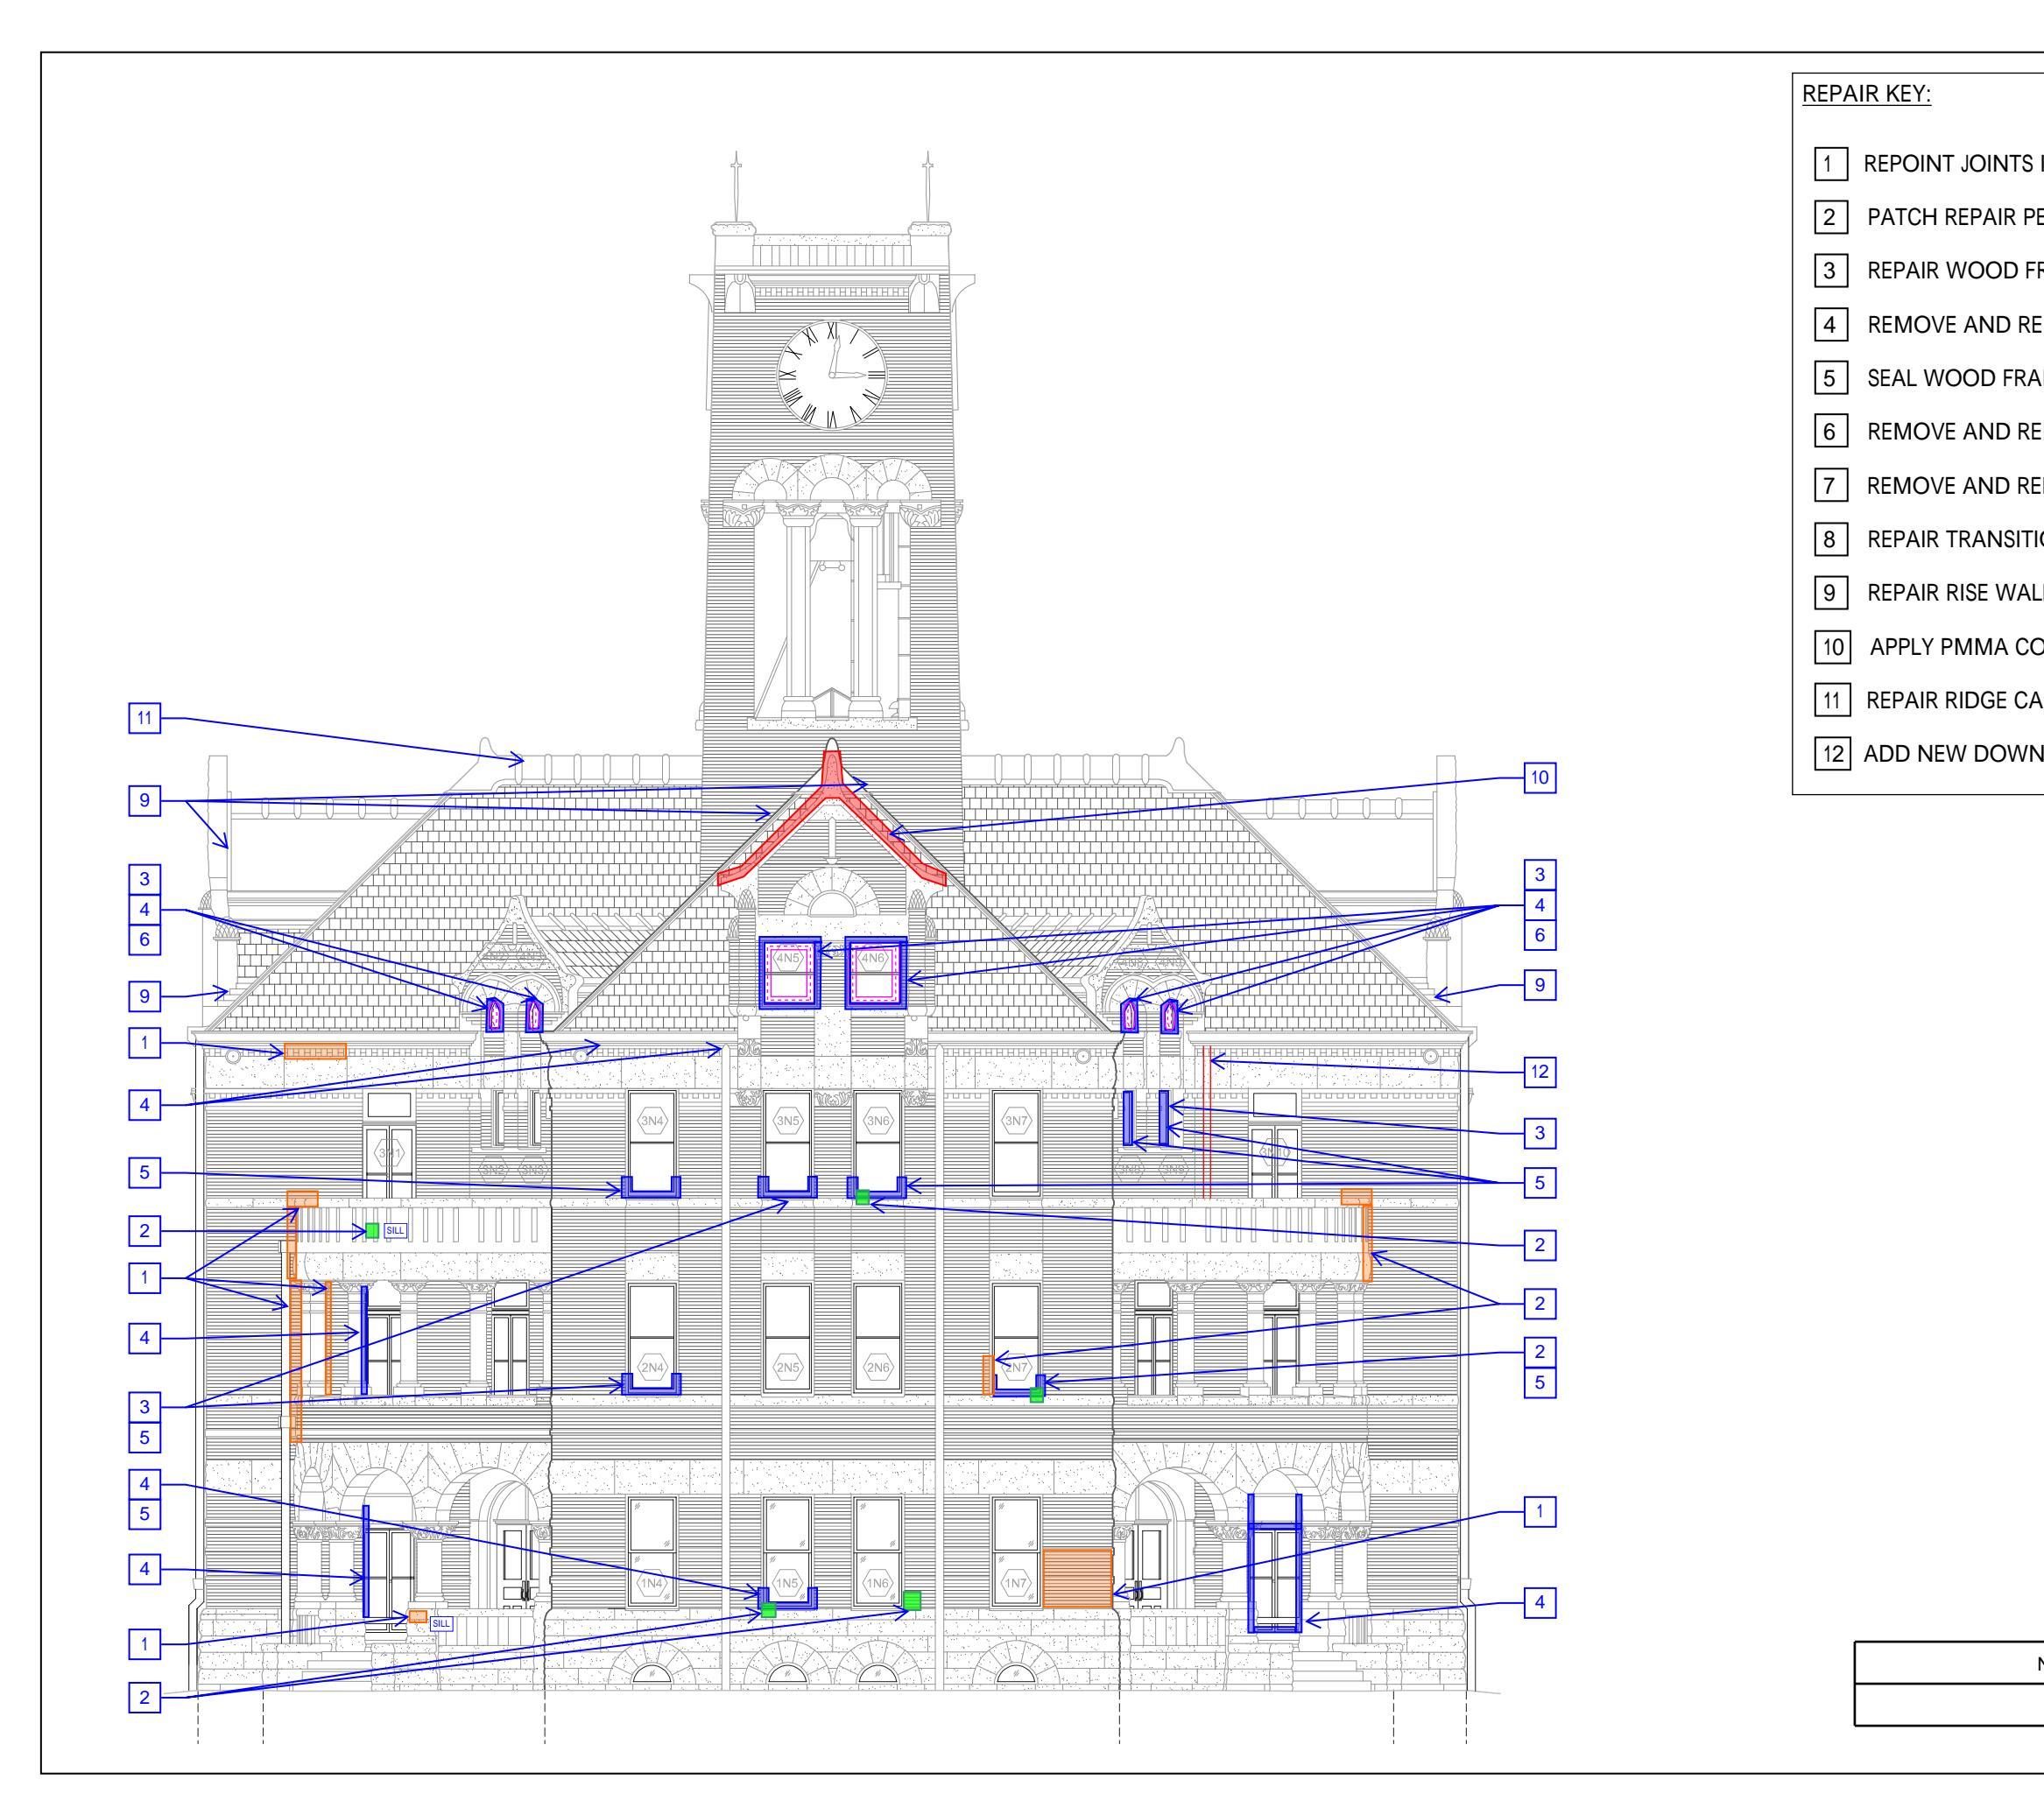
,	1			
IN MASONRY PER 1/R3.0 ER 2/R3.0 RAME COMPONENTS PER 3/R3.1		SEAL	ERIKAL BONFANTI	23: 116824	
PLACE SEALANT PER 4/R3.1					
EPLACE GLAZING PUTTY PER 6/R3.1					
PLACE GLASS UNIT					ר ע
ON FLASHING PER 8/R3.2				Ď	2
L FLASHING PER 9/R3.2				SHEET	
DATING PER 10/R3.3				0,	
APS PER 11/R3.3					
SPOUT [SUBJECT TO THC REVIEW]					
				REVISION	REV. DATE
		ltration		DRAWN BY elb	CHECKED BY JAA
		PROJECT Lee County Courthouse Repairs to Address Water Infi	CLIENT Honorable Judge Paul E. Fischer Lee County, Texas	PROJECT NO. 2018.0023	DATE March 9, 2019
NORTH ELEVATION 1 scale: NTS				ACTON PARTNERS, LLC PO Box 203663	Austin, Texas 78720 TBPE Firm F-16437 www.actonpc.com

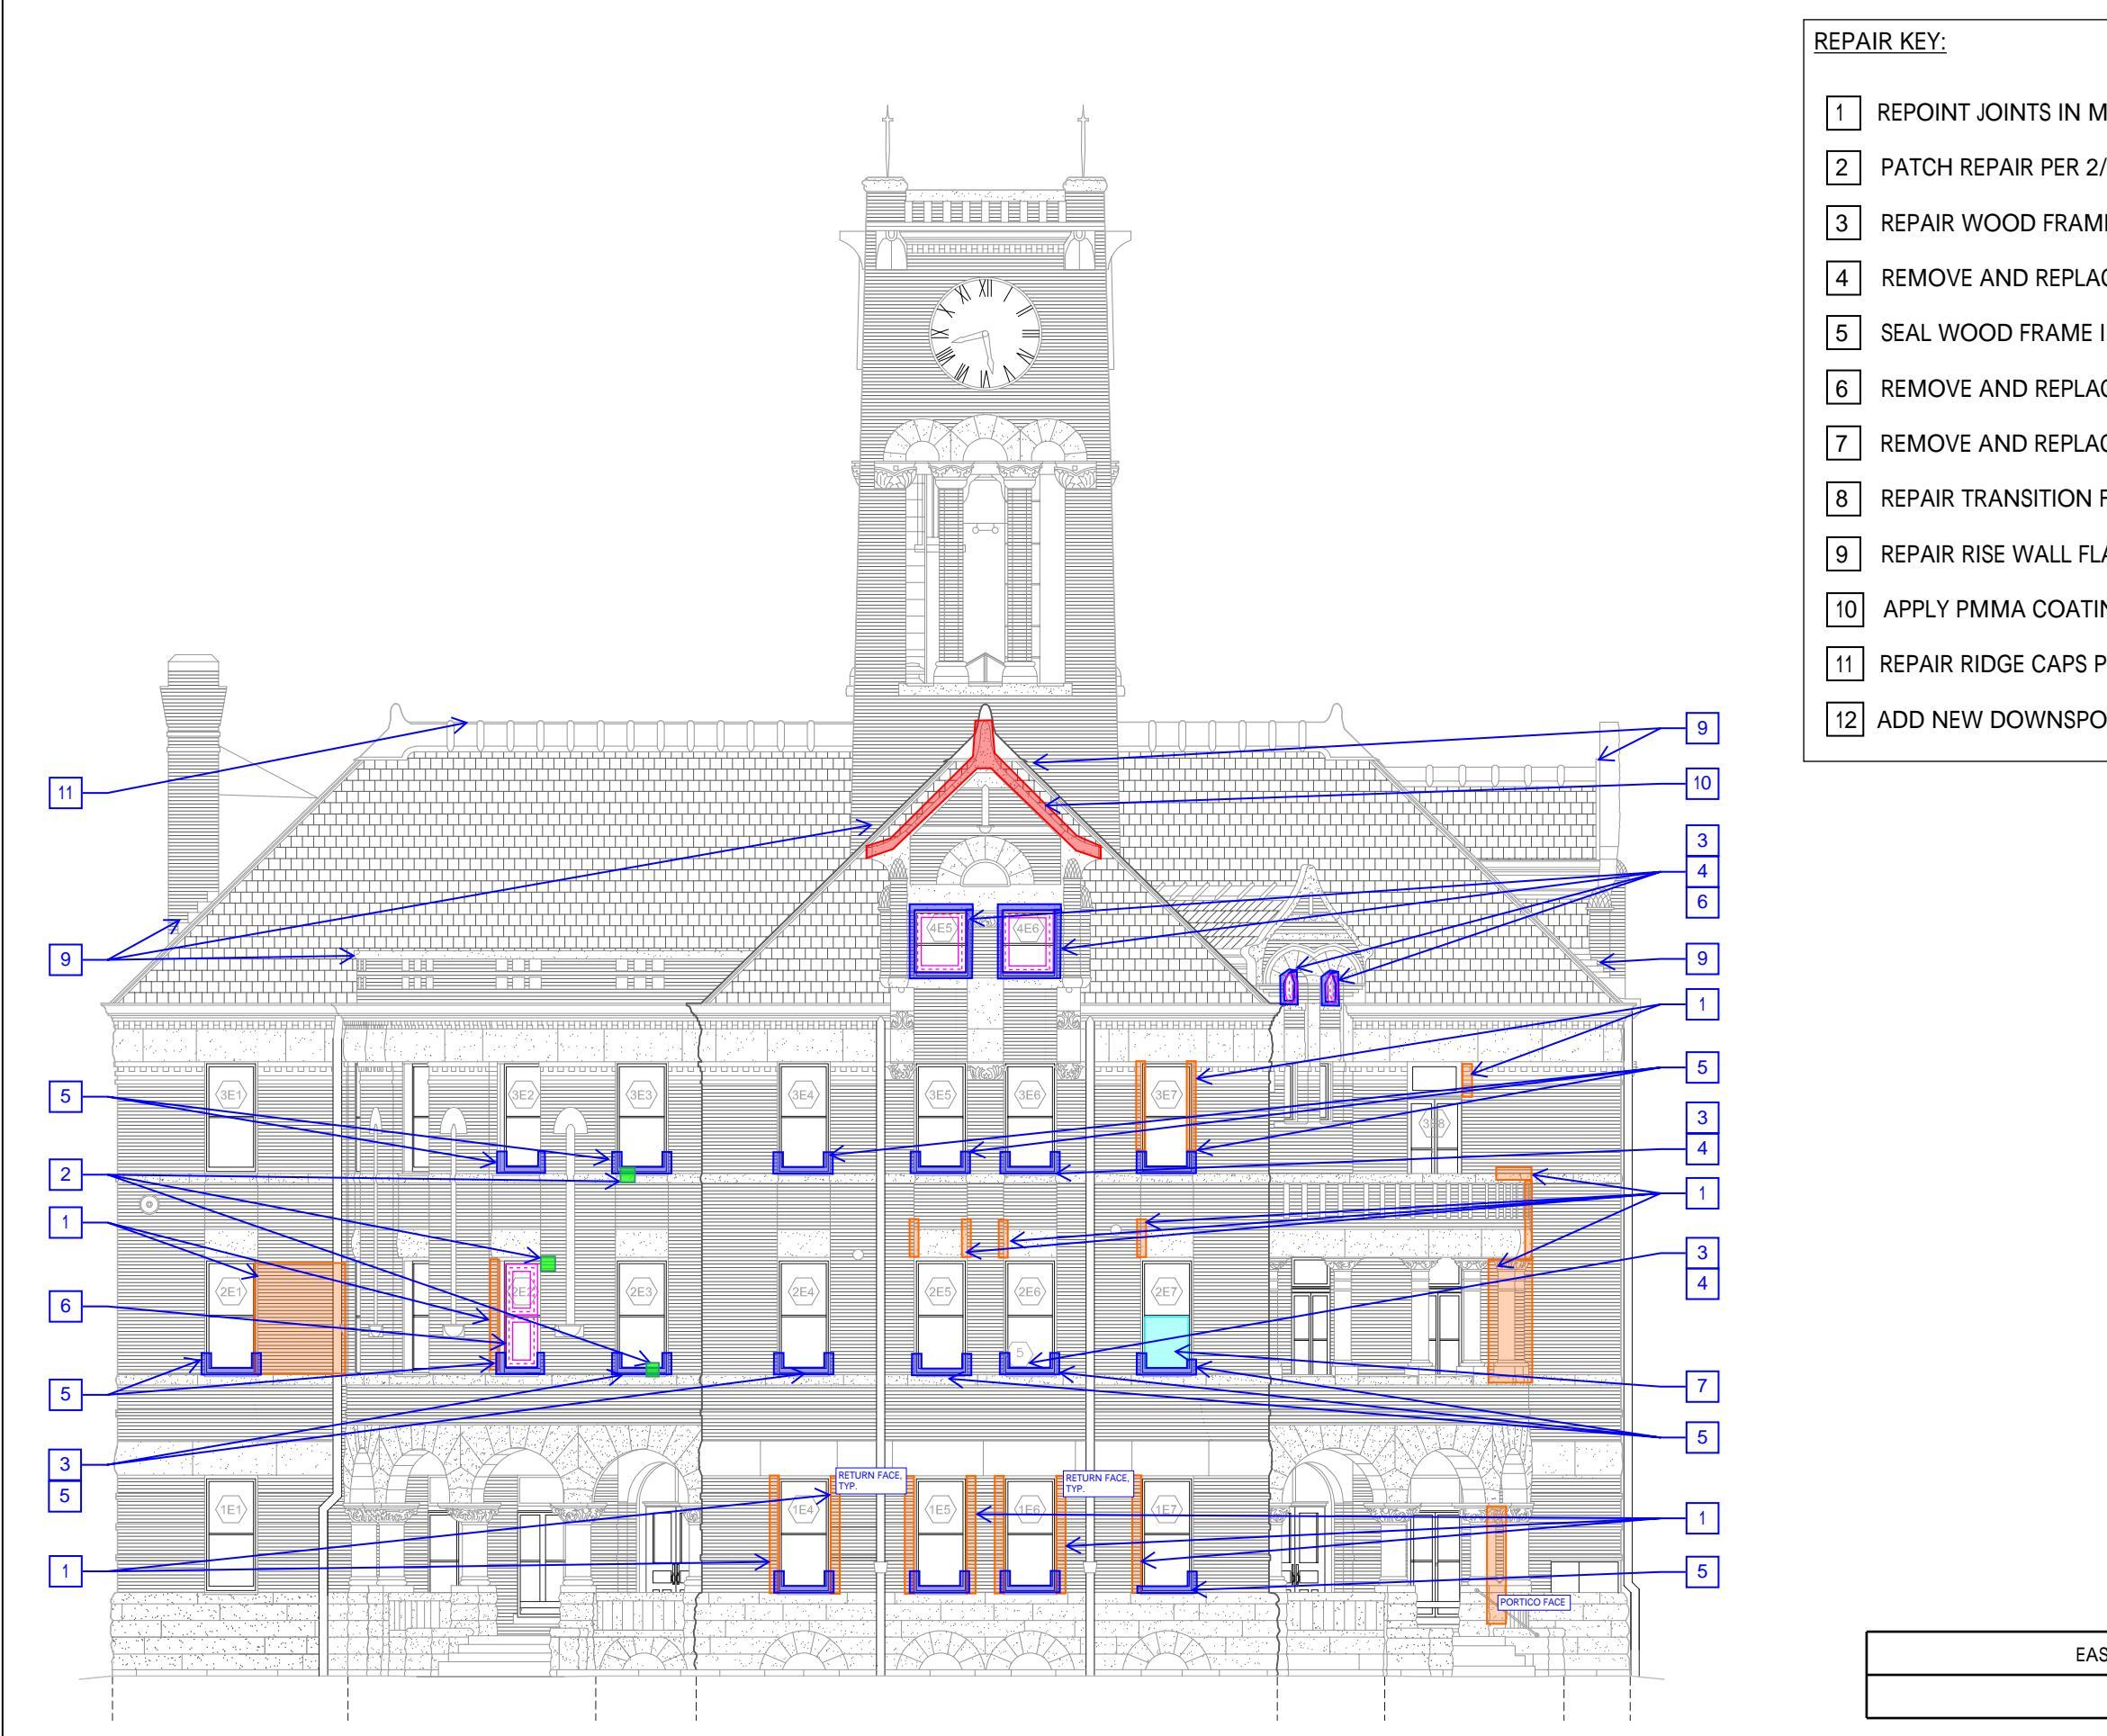
IN MASONRY PER 1/R3.0 ER 2/R3.0 RAME COMPONENTS PER 3/R3.1	SEAL	ERIKAL BONFANTI	43: 116824	
AME INTERSECTIONS PER 5/R3.1				
				_
ION ELASHING PER 8/R3 2				2
L FLASHING PER 9/R3 2			EET	
DATING PER 10/R3.3			<u> 곳</u>	
APS PER 11/R3.3				
NSPOUT [SUBJECT TO THC REVIEW]				
			REVISION	REV. DATE
	Itration		DRAWN BY elb	CHECKED BY JAA
	PROJECT Lee County Courthouse Repairs to Address Water Infi	CLIENT Honorable Judge Paul E. Fischer Lee County, Texas	PROJECT NO. 2018.0023	DATE March 9, 2019
EAST ELEVATION 1 scale: NTS			ACTON PARTNERS, LLC PO Box 203663	Austin, Texas 78720 TBPE Firm F-16437 www.actonpc.com

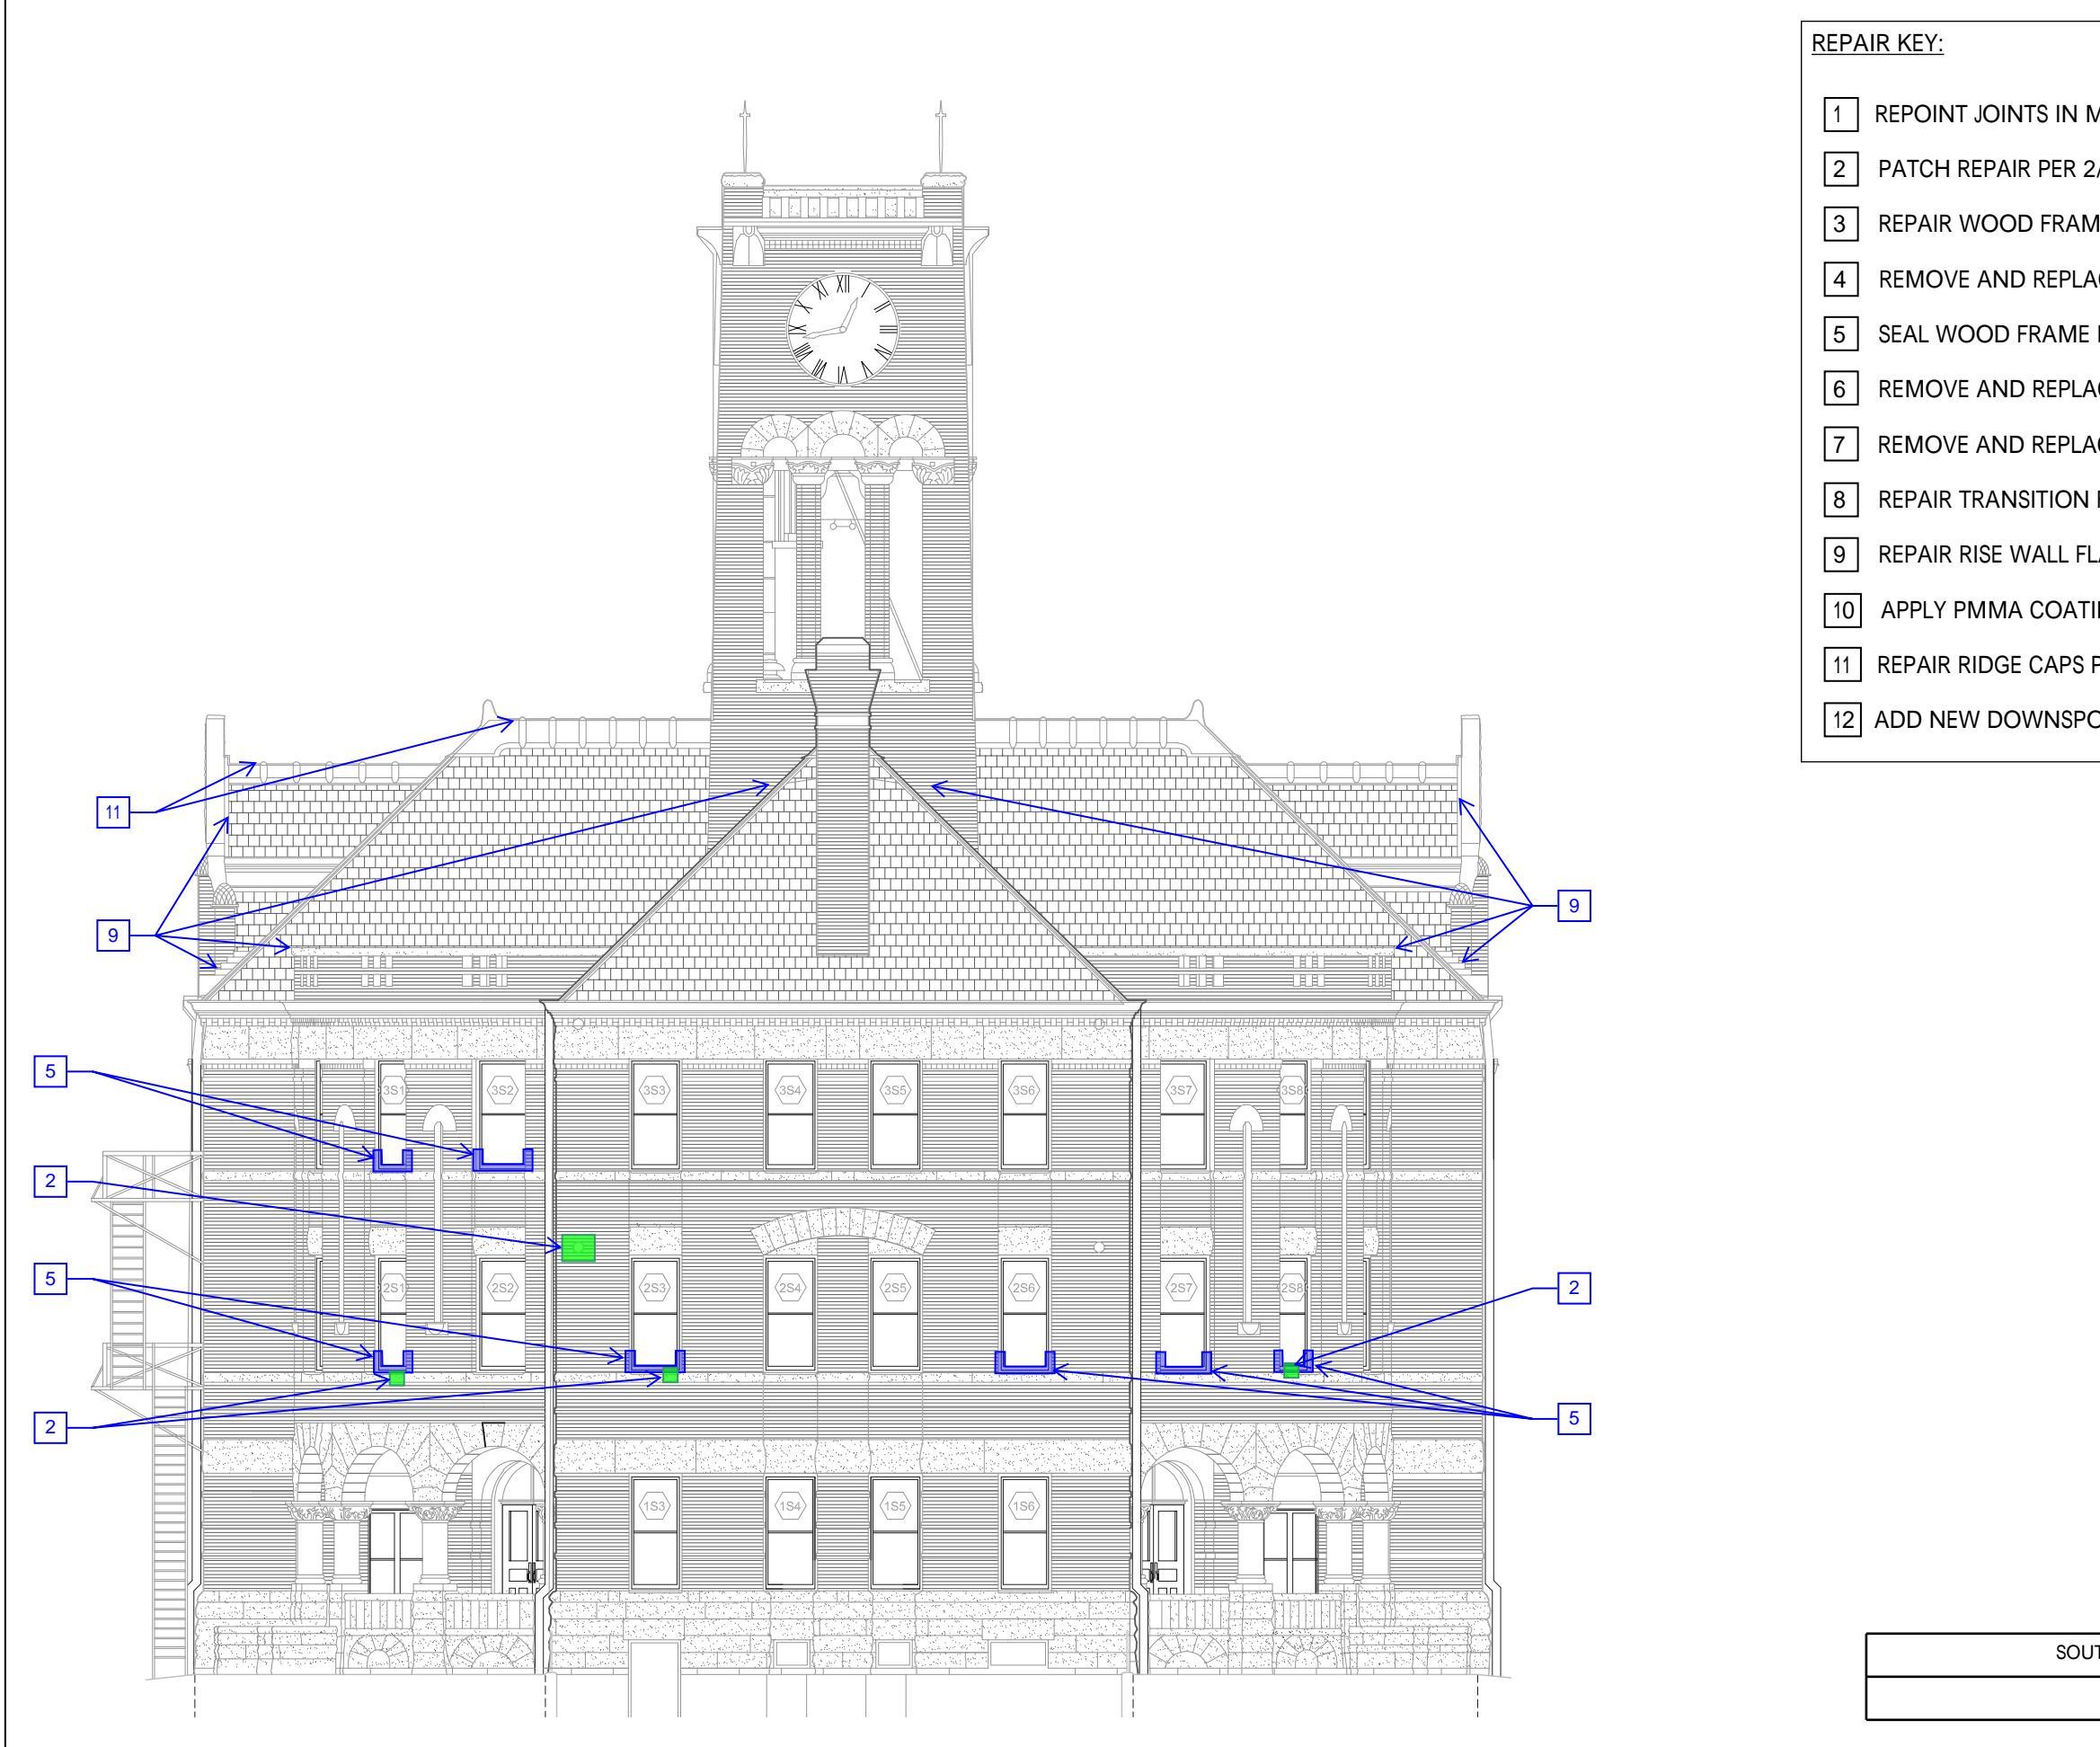
in the second	s** E	HI NEE	b .
IN MASONRY PER 1/R3.0	OF TE	BONFA	6824 ENSED	1000 M
PER 2/R3.0	ALE CON		11(55/CE	
RAME COMPONENTS PER 3/R3.1		·** []	PROF	
EPLACE SEALANT PER 4/R3.1	SEA			
AME INTERSECTIONS PER 5/R3.1				
EPLACE GLAZING PUTTY PER 6/R3.1			C	V
EPLACE GLASS UNIT			C	Ņ
ION FLASHING PER 8/R3.2				C
LL FLASHING PER 9/R3.2			SHEET	
OATING PER 10/R3.3				
APS PER 11/R3.3				
NSPOUT [SUBJECT TO THC REVIEW]				
			NOISI	. DATE
			REV	REV
			<u>व</u>	
	ç		N BY	ED BY
	filtratic		DRAWI	CHECK
	se 'ater In	Fischer		
	urthou ress W	e Paul E. Is		
	inty Co to Add	le Judge ity, Texa		0,00
	ee Cou epairs	onorab ee Cour	D. 018.002	-
	DUECT	ENT	OJECT N	E
	PRO	СП	PR	DA
			, LLC	0.
		₹₽`	TNERS 203663	xas 7872 n E-16437
SOUTH ELEVATION 1			DN PAF	Vustin, Te
scale: NTS			ACTO

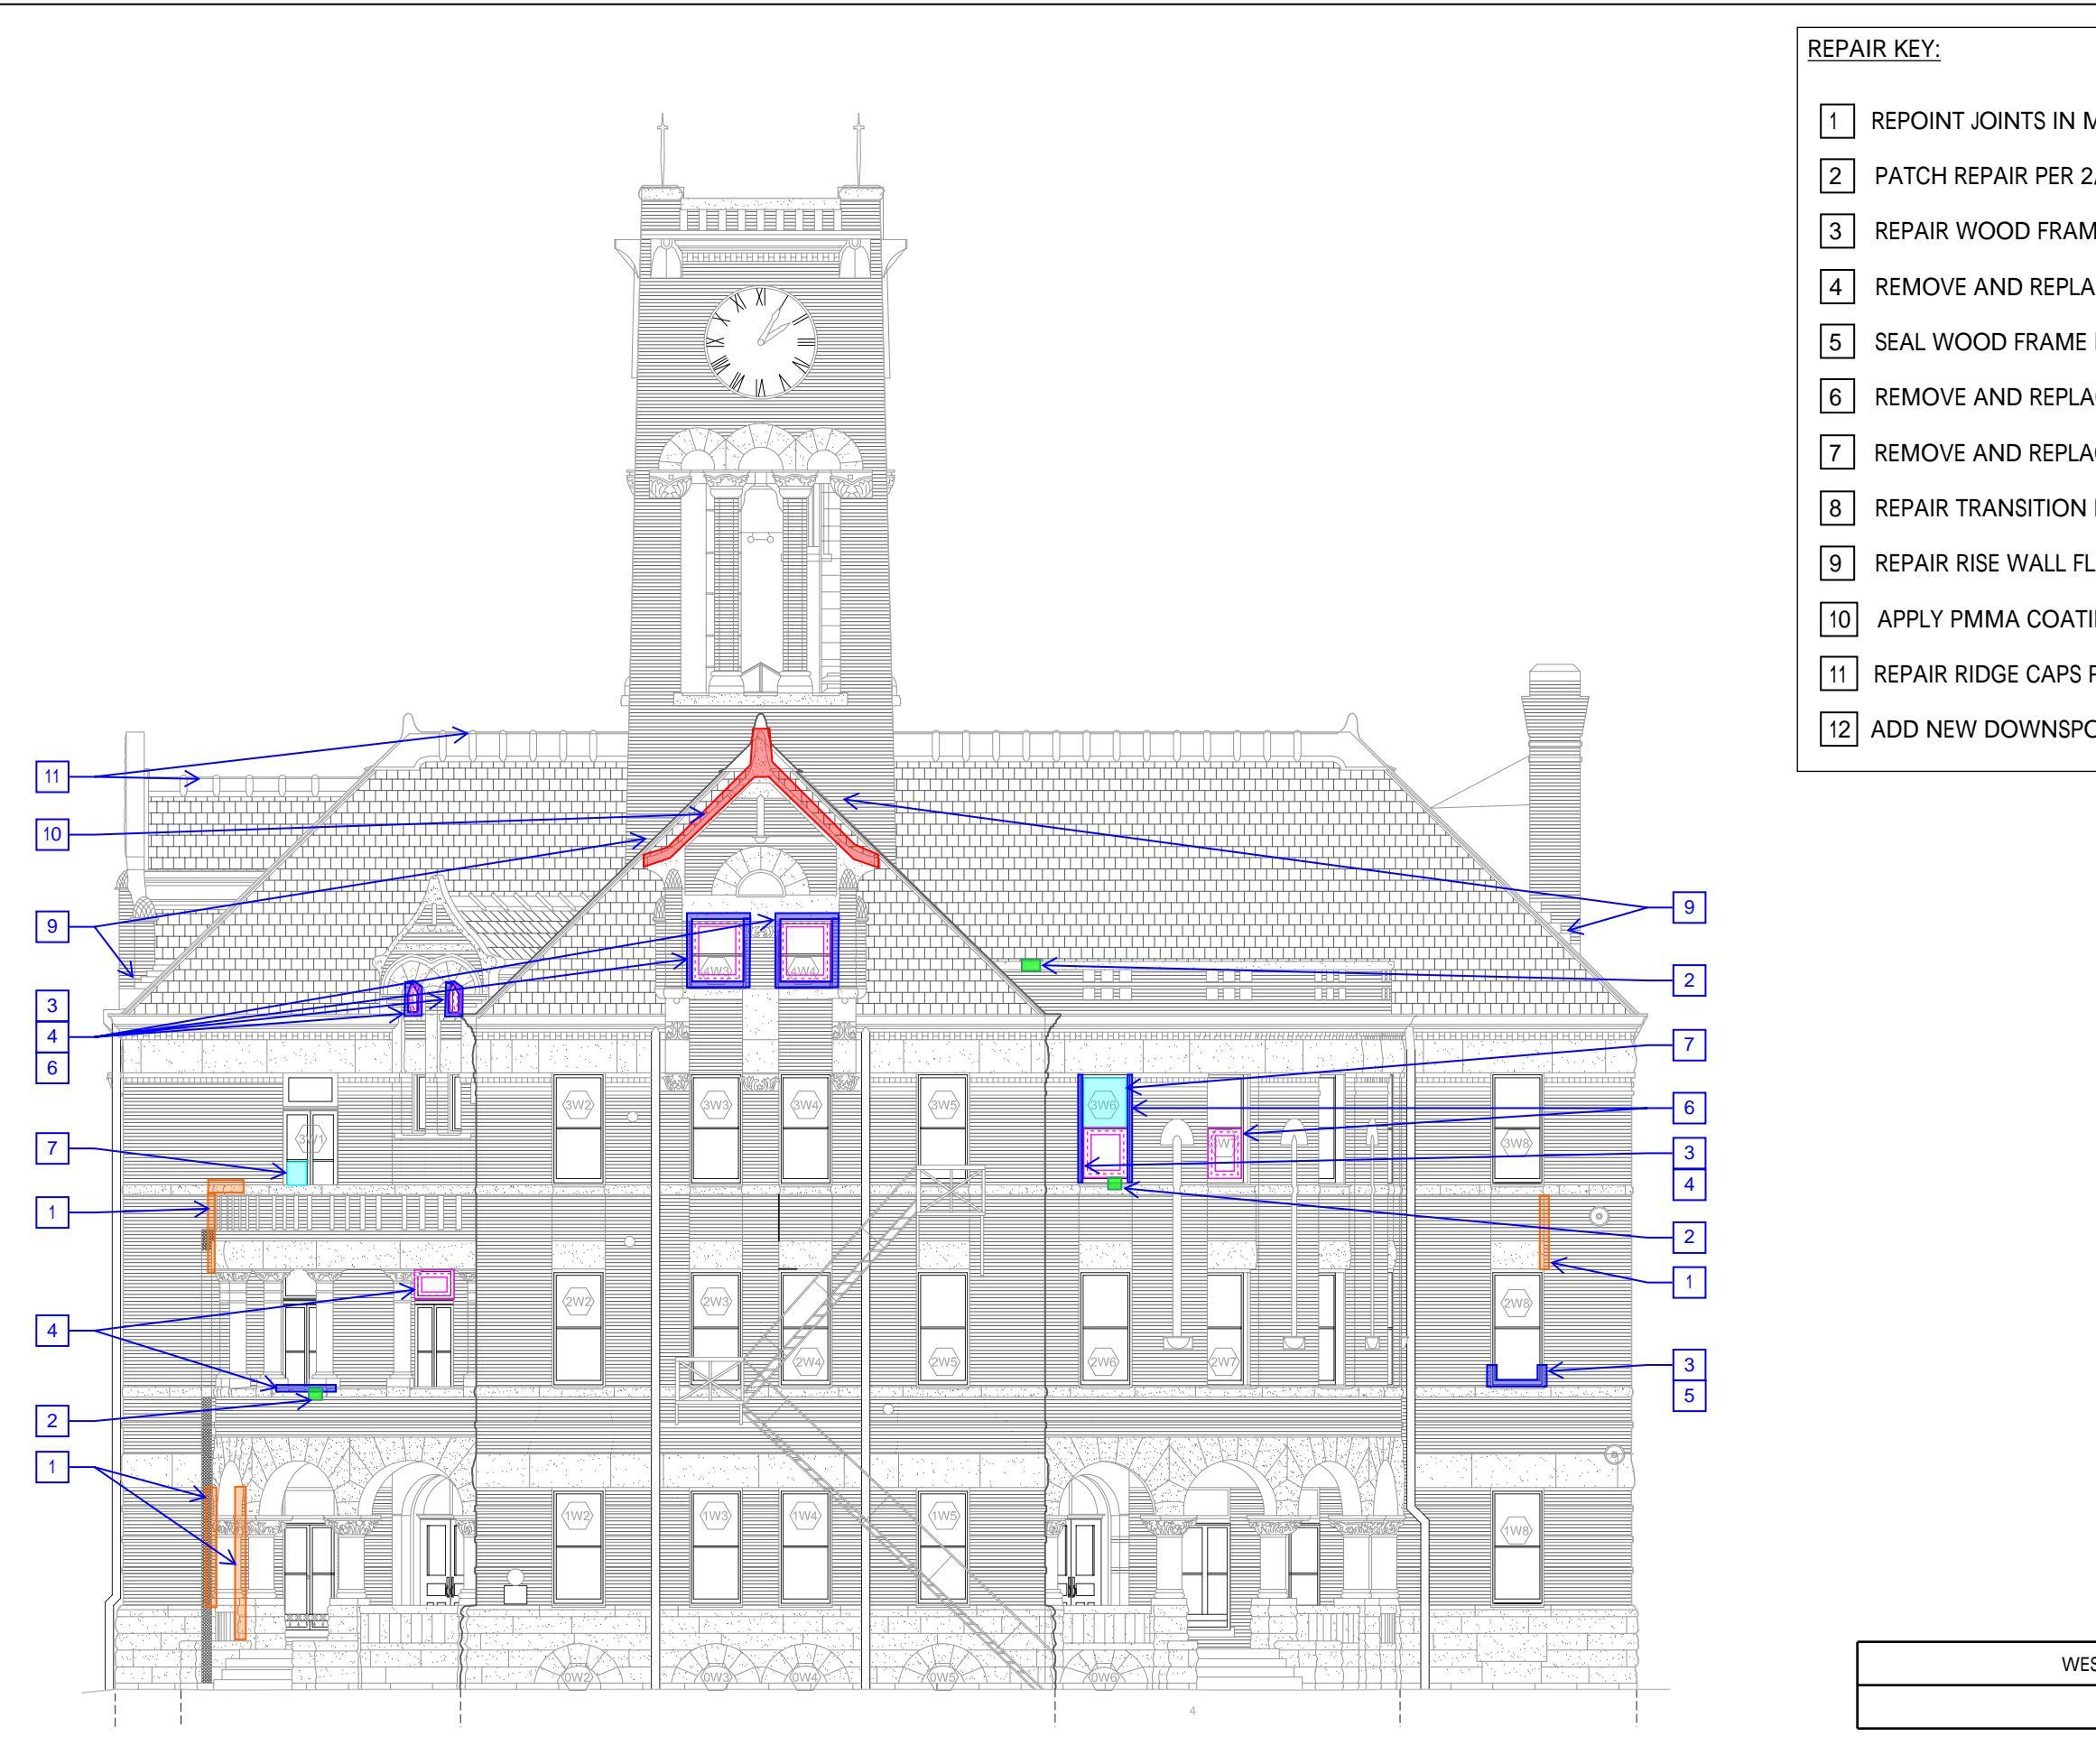
R2.3

1		
		S*** ENA	HIJAN IS
N MASONRY PER 1/R3.0	5	BONE	6824 ENSE
R 2/R3.0	A HIN	RIKAL	11
RAME COMPONENTS PER 3/R3.1	Ч (7	WWWWW	PROT
PLACE SEALANT PER 4/R3.1	SE/		
ME INTERSECTIONS PER 5/R3.1			
PLACE GLAZING PUTTY PER 6/R3.1			c
PLACE GLASS UNIT			C
ON FLASHING PER 8/R3.2			
L FLASHING PER 9/R3.2			SHEET
DATING PER 10/R3.3			
PS PER 11/R3.3			
SPOUT [SUBJECT TO THC REVIEW]			
			lision
			REV
			٩
			BY el
	lltration		DRAWN
	e iter Infi	-ischer	
	irthous ess Wa	Paul E. I	
	ity Cou	t Judge y, Texas	
	e Cour pairs te	norable e Count	8.0023
	ECT Le Re	H Lee	JECT NO 20
	PROJ	CLIEI	PRO
			TC
			NERS, L 33663
WEST ELEVATION 1	$ \leq$		N PART
scale: NTS			ACTOI
